# Cry, the beloved railway revisiting the Barkly East branch line

Prepared by the 2012 BERRT group:  
Johannes Haarhoff, Francis Legge  
Mike Johns, Bill James, Johan de Koker

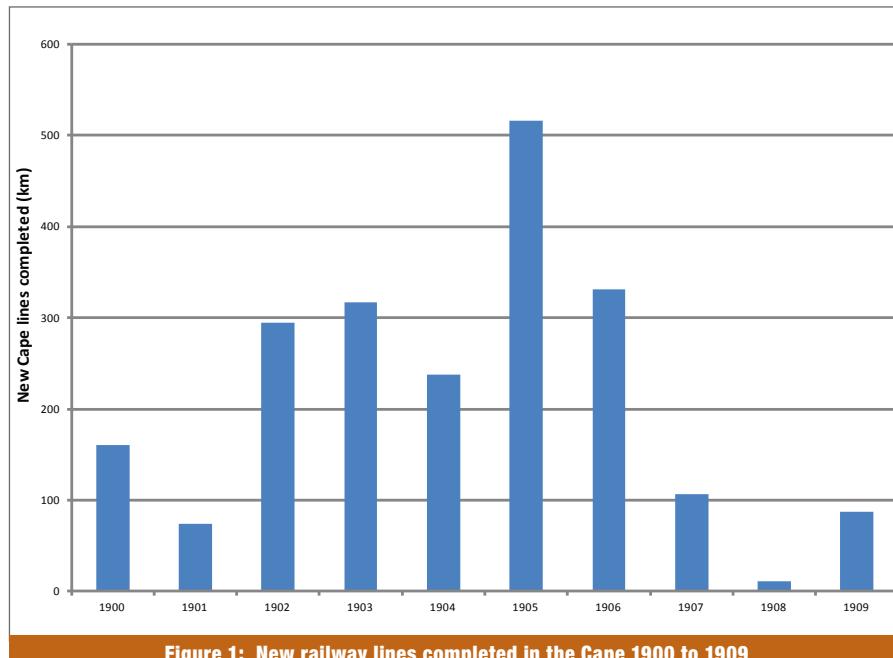
Figure 1: New railway lines completed in the Cape 1900 to 1909

- Section 1 was built at a time of national reconstruction following the end of the South African War, when almost every district was clamouring for rail access. Funds were stretched widely.
- Cape rail construction tapered off dramatically after 1905, as shown in Figure 1, and the line was implicated.
- From about 1906, large capital investment by government, which included new rail construction, was inhibited by the pending unification of South Africa in 1910, holding to the well-established principle that projects could only be approved if *“those that have to pay have a voice in the expenditure incurred”*.

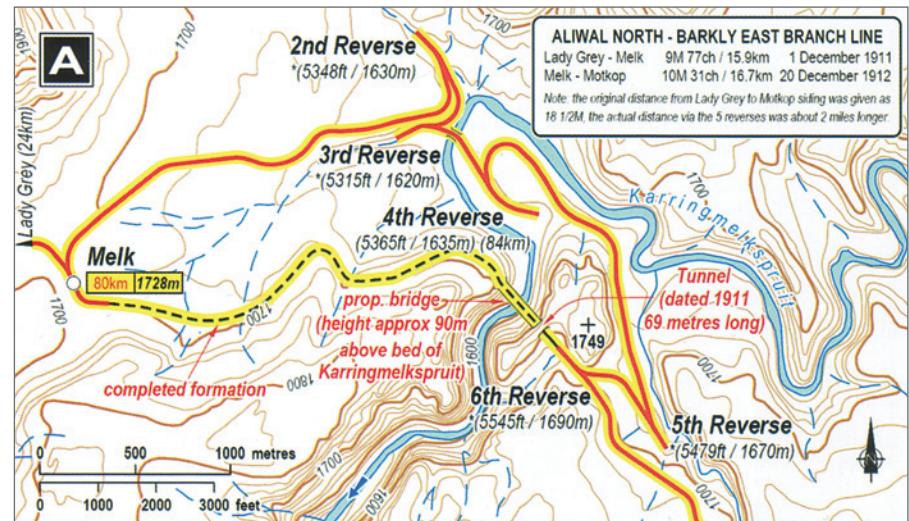
**Figure 2: Map of the reverses area near Barkly East; the dashed line indicates the originally planned crossing of the Karringmelkspruit by a high bridge, eventually replaced by a series of six rail reverses (map originally drawn by Bruno Martin, published in *Tracks Across the Veld* by Boonzailer in 2008, used with permission)**

Rail alignment incurs severe geometrical constraints, forcing engineers to consider all possible options. Following a “flying survey” in 1899, probably performed on horseback with primitive surveying instruments (if any), George Schele, reporting his findings to none other than John Brown (soon thereafter the first president of SAICE in 1903), first suggested a route. His proposal was based on a rail gauge of 2 feet (mensuration at the time, 610 mm today) and would have crossed the Karringmelkspruit on a low bridge at exactly the same point where the rail crosses today. His proposal did not include any reverses, but he admitted that the route “could hardly be selected if the gauge was of standard width” (the standard Cape gauge of 3 feet 6 inches, or 1 067 mm). Soon thereafter, following a more detailed survey in 1903, resident engineer Allan McDonald Campbell boldly proposed a route that would cross the Karringmelkspruit about 1 000 m further downriver in the gorge, requiring a high bridge 93 m above the river bed. Moreover, at the eastern end of the bridge, the line would immediately enter a tunnel only 70 m long, exiting on a small plateau and continuing in regular fashion. When crews moved onto site in 1910, this proposal, which accommodated the wider gauge, was approved and tunnel construction started forthwith, in parallel with the bridge design. Understandably, the bridge design team (who had to be paid for many hours of overtime) finally came up with a cost estimate significantly higher than that budgeted for. Stringent budget controls imposed by parliament could not be exceeded, so Campbell’s grand design was scrapped and an alternative system of six reverses was hastily constructed. Three reverses allow the line to descend steeply to cross the Karringmelkspruit at the same low level that Schele had suggested, and via three more reverses to rise again to the plateau immediately east of the tunnel.

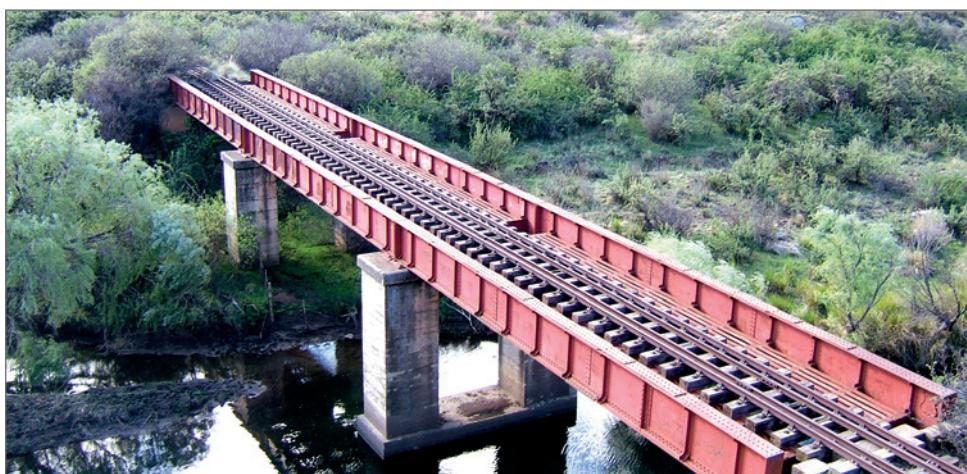
**Manufactured by Westwood Baillie & Co in London in 1884, the three 40 feet (12.2 m) deck sections of the Karringmelkspruit rail bridge first served near Prieska before being moved to their present location in 1912/13**

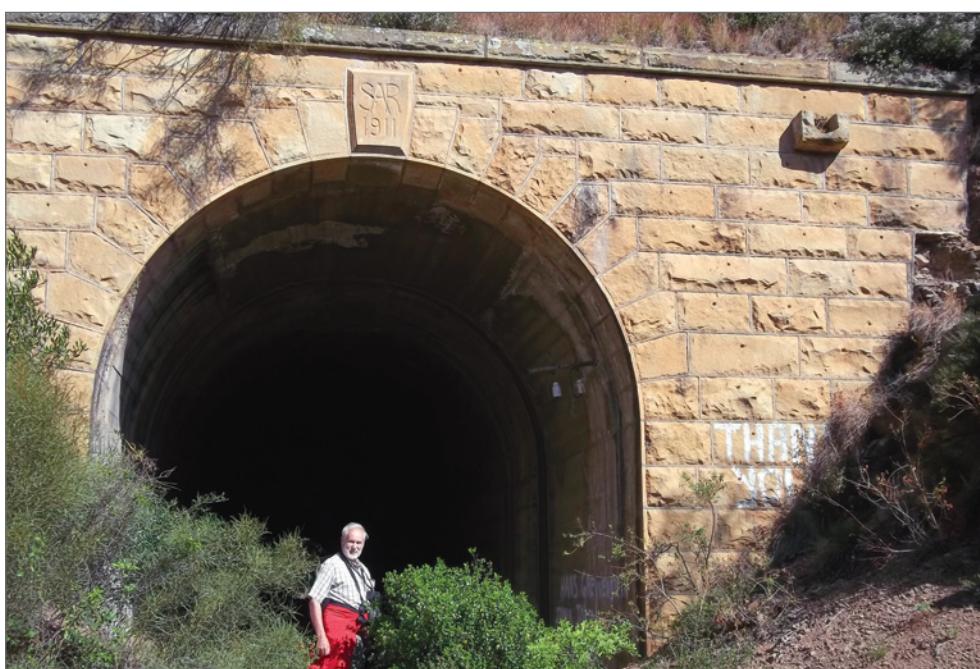
**Concrete-lined over its entire 70 m, both portals of the abandoned rail tunnel incorporate one “SAR 1911” keystone; fine sandstone masonry is typical of the area**

tunnel and the approach earthworks for the high-level bridge had been completed in August 1911. Naturally this led to an embarrassing situation: an expensive, complete, lined railway tunnel, worthless and unusable to this day. Additionally, the rail formation constructed on side-long ground on the western approach to the proposed high-level bridge has left a hillside scar visible to the present. For the first decades following the tunnel construction, it was commonly reported and generally accepted that abandonment of the tunnel and its approach formation ending in a short but deep curved cutting, was caused by an unavoidable shortage of money. Latterly, however, a number of myths have arisen to explain why the tunnel and formation were abandoned and the bridge design aborted; some are listed below, all easy to disprove by simply considering the timeline:

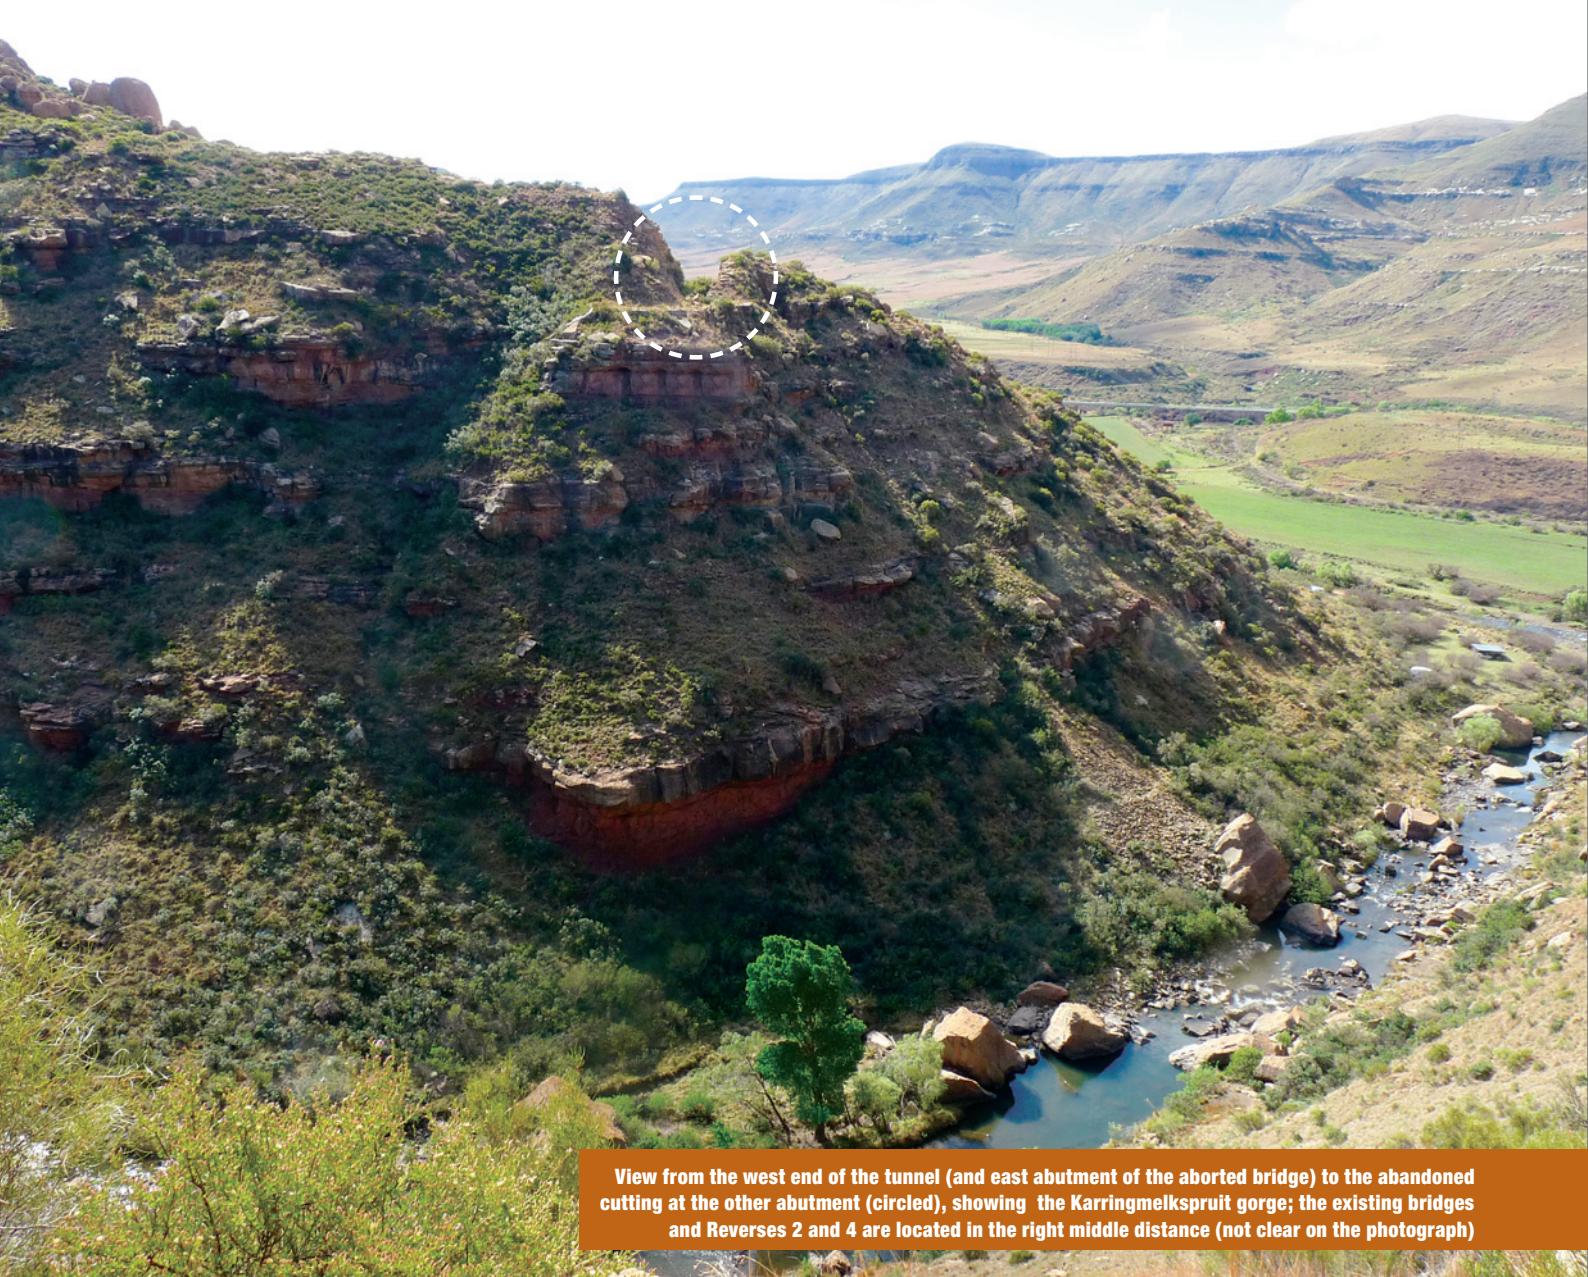
View from the west end of the tunnel (and east abutment of the aborted bridge) to the abandoned cutting at the other abutment (circled), showing the Karringmelkspruit gorge; the existing bridges and Reverses 2 and 4 are located in the right middle distance (not clear on the photograph)

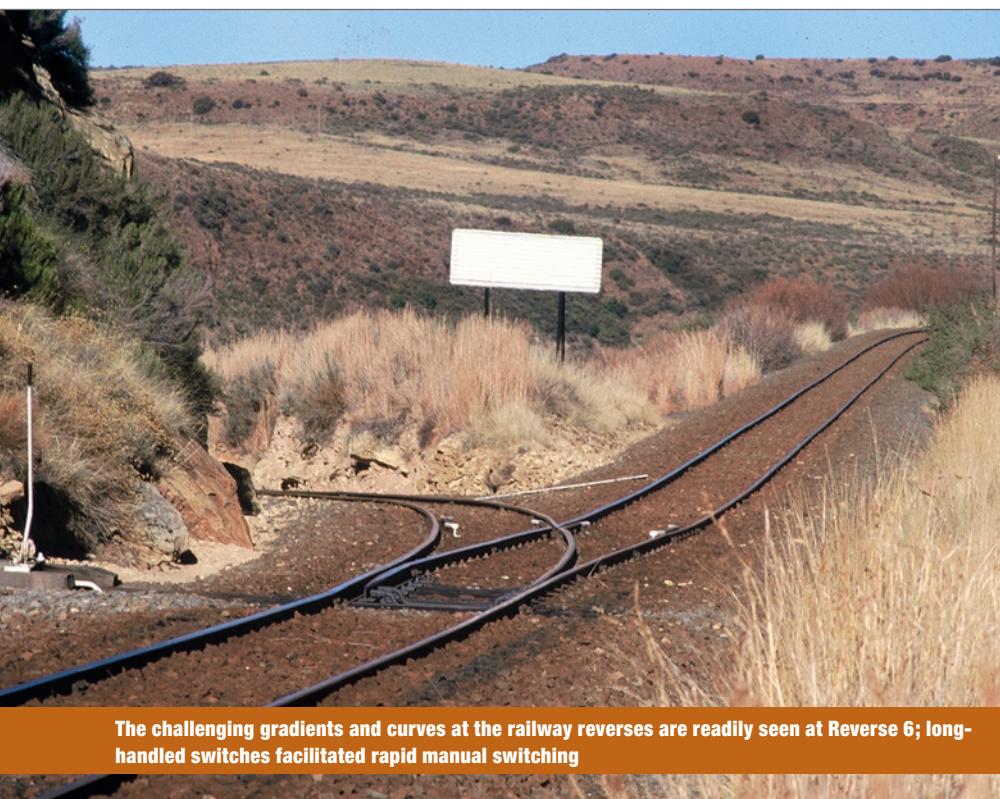
The challenging gradients and curves at the railway reverses are readily seen at Reverse 6; long-handled switches facilitated rapid manual switching

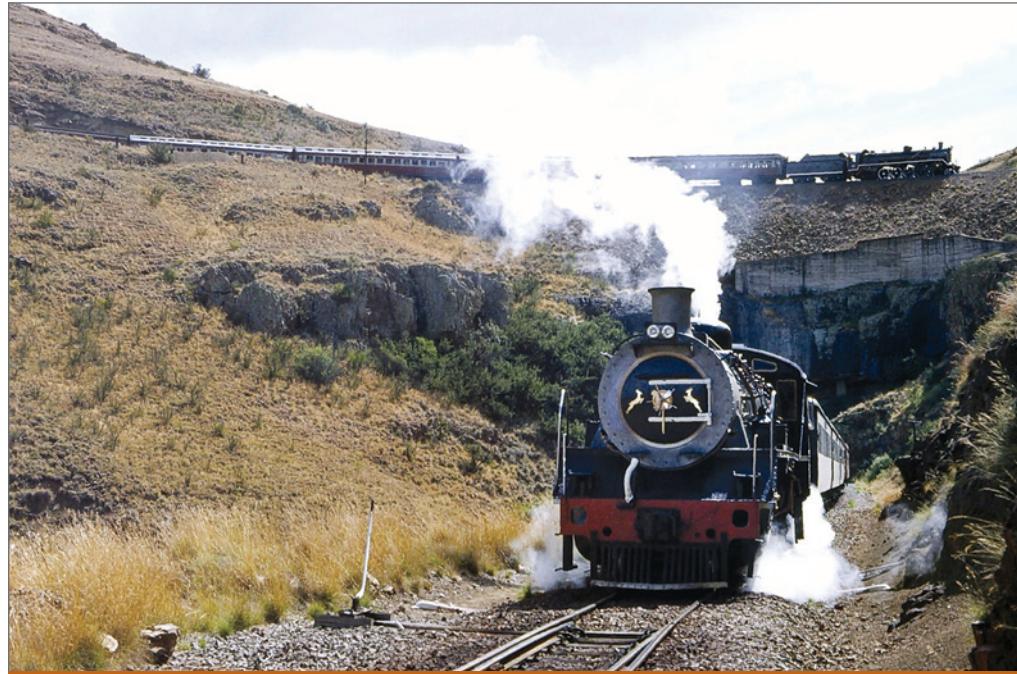
**Railway reverses limit the length of trains; here a Class 19 has tightly backed up its coaches at Reverse 8, only a few metres beyond the switch, while another approaches Reverse 7 (Photograph by HG Graser, [http://de.wikipedia.org/wiki/Bahnstrecke\\_Aliwal\\_North%2880%93Barkly\\_East%29](http://de.wikipedia.org/wiki/Bahnstrecke_Aliwal_North%2880%93Barkly_East%29))**

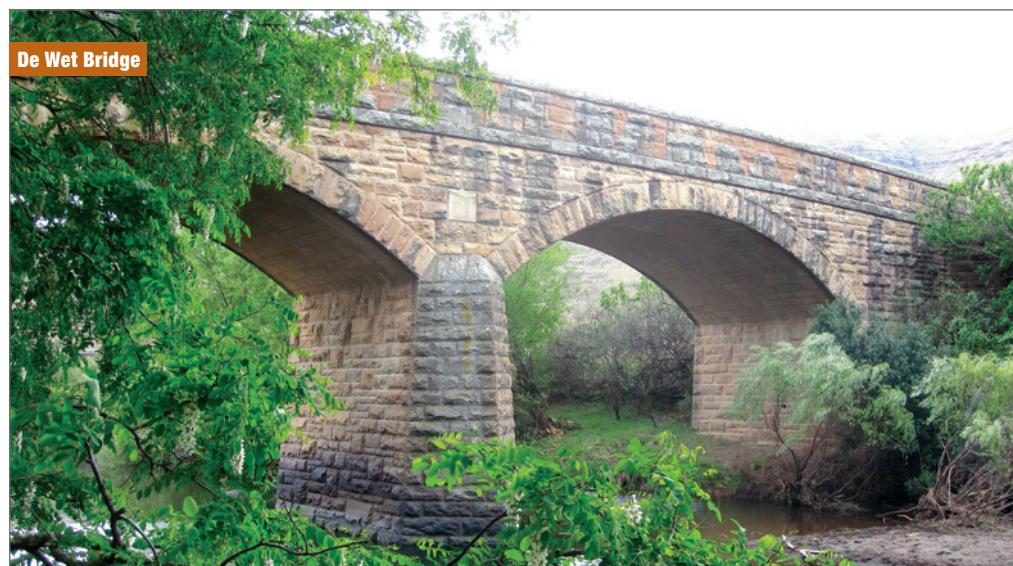
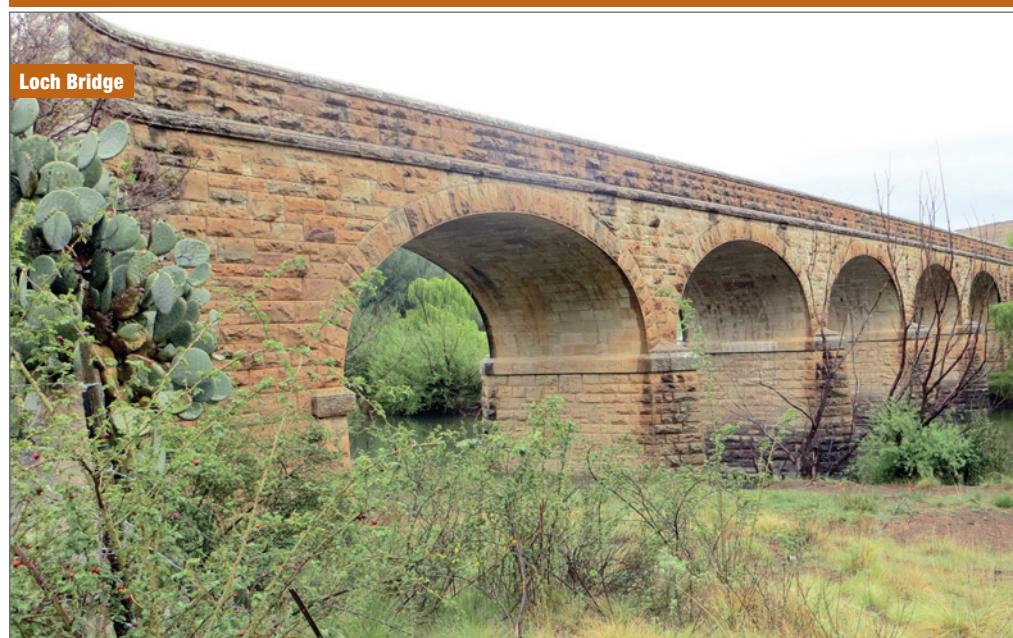
**These two beautiful sandstone bridges, both designated national monuments, are in close proximity of the railway line – completed in 1899, the De Wet Bridge crosses the Karringmelkspruit near Reverse 4 about 11 km southeast of Lady Grey, while the Loch Bridge (officially named the John Laing Bridge, for the Commissioner of the Cape Department of Public Works), completed in 1893, crosses the Kraai River near Reverse 8 about 8 km northwest of Barkly East**
